Apartment building “Sodastraße 40” in Ludwigshafen, DE

Renovation of an apartment building with exposed brickwork, built in 1892. 78% reduction of annual heat energy demand with interior insulation (according to PHPP).

IEA – SHC Task 37

Advanced Housing Renovation with Solar & Conservation

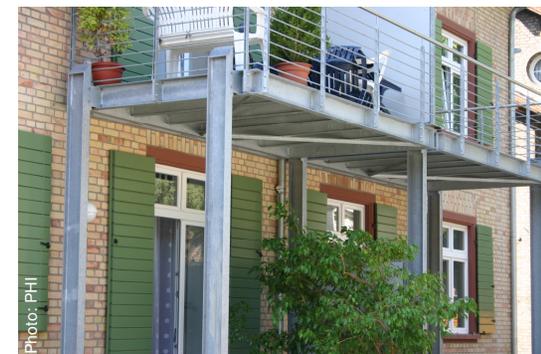
Reduction of thermal bridges by constructing new stand-alone balconies.

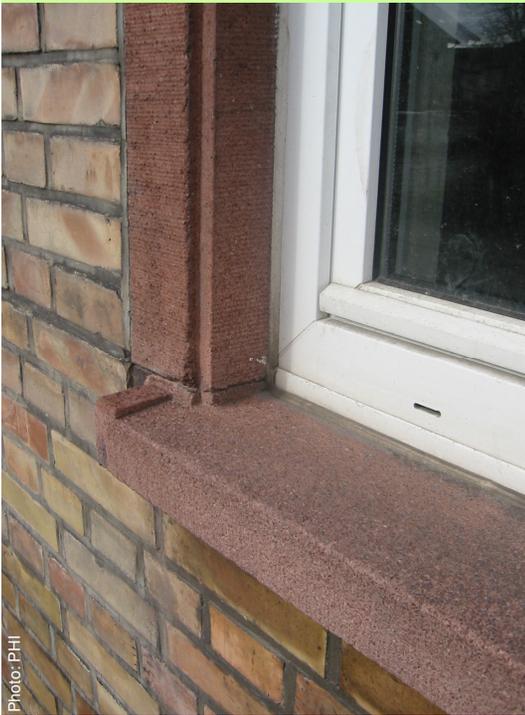
Insulated window frame at the same position.
Reduction of thermal bridges by connecting
the interior insulation (see page 5)

The vapour barrier or retarder covering an interior insulation has to be meticulously air tightly bonded to the adjoining surfaces below, at the ceiling and at inner walls to avoid infiltration of the room humidity into the interior insulation.

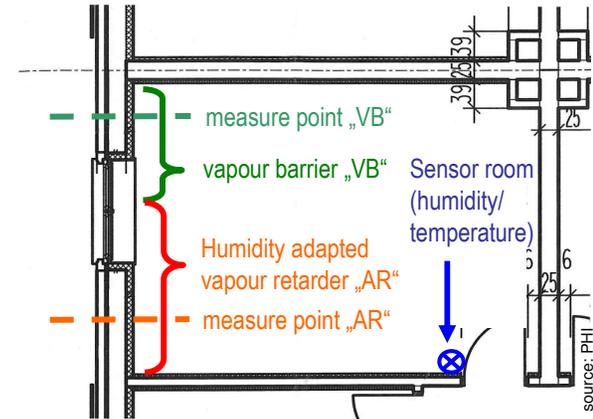
Floor plan of the analyzed room

In one first floor room the interior insulation was partially covered with a vapour barrier over gypsum board. The other part was covered with a humidity adapted vapour retarder. In both parts sensors were installed at the depth of the former interior plaster. After 19 months the relative humidity at this depth dried to 70 % in the area of the humidity adapted vapour retarder. In the vapour barrier area this value was reached after 32 months.

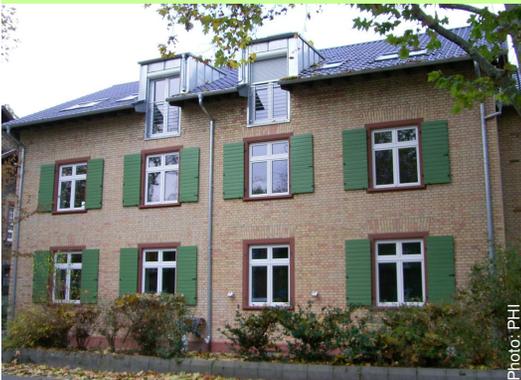
Position of the two driving rain sensors

At the exterior wall two driving rain sensors were installed. The existing brickwork showed an extremely high hygroscopicity. Therefore the humidity in the expanded brickwork, in spite of the normal double hydrophobization of the façade, increased considerably after driving rain. It dried slowly over several months, which is inadequate for an interior insulation regardless of the vapour barrier or vapour retarder. The dynamic simulation showed, that in case of this brickwork an adequate protection against driving rain is provided with a fourfold hydrophobization. This analysis shows the need of a preliminary inspection to ensure the efficiency of hydrophobization especially with the use of interior insulation.

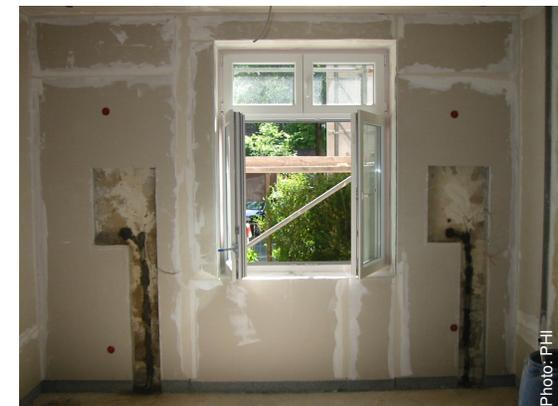
Analyzed room with opened areas for the installation of the sensors.

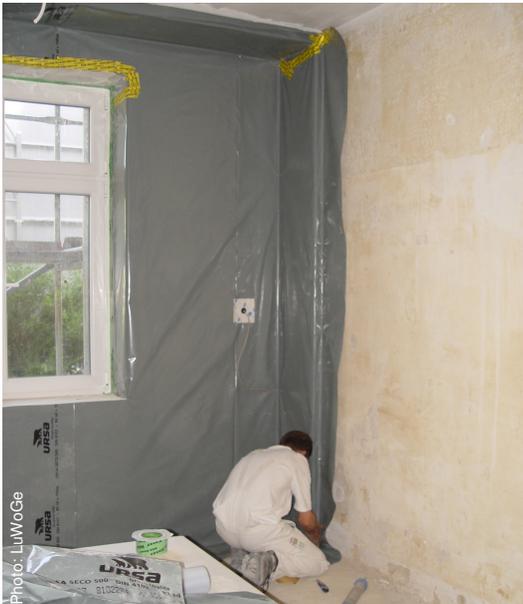
Installation of the vapour barrier

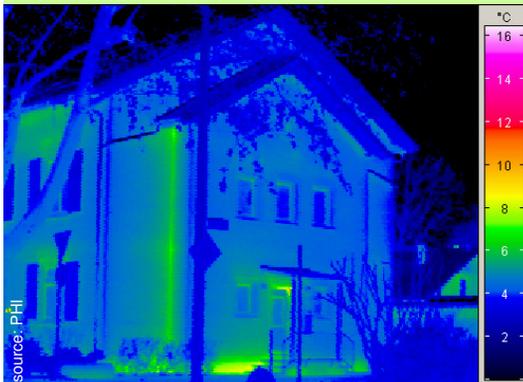
Thermography of the refurbished building
