Lessons from Exemplary Housing Renovations

Task 37 Advanced Housing Renovation with Solar and Conservation / Subtask B

Robert Hastings¹ AEU GmbH CH-8304 Wallisellen robert.hastings@aeu.ch

21. March 2010

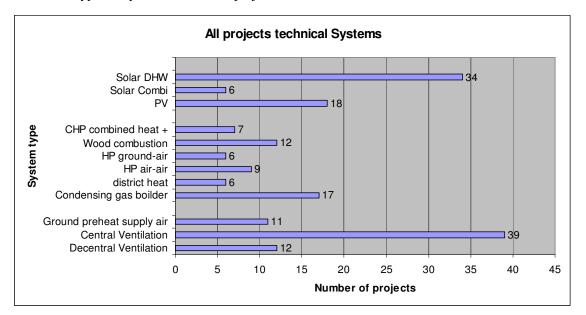
Table 1.4: Types of systems used in the projects

Of the 60 projects, 51 had mechanical ventilation with some form of heat recovery. The majority were central systems (39). Non-central systems included room ventilation units, i.e. thru-wall units or window frame slits. 11 projects preheated supply air in buried earth channels. One project used façade-mounted solar air collectors to preheat supply air entering the room behind the wall (512 APT for Elderly in Stuttgart DE). The average efficiency of the heat exchangers was 84%.

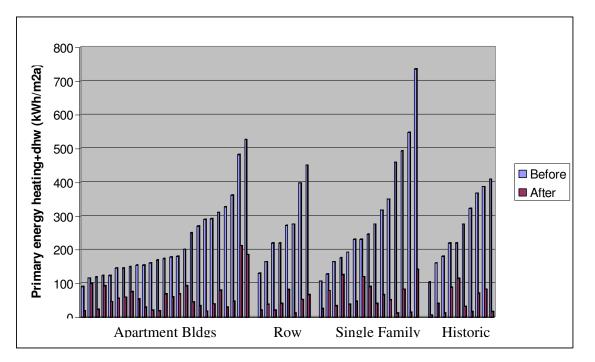
It can be observed that by all housing types dramatic energy savings are possible. Not graphed are the two projects with added attica apartments, because there is no before energy consumption for comparison. All together, the 58 projects achieved on average 83 percent energy savings. The greatest savings for this collection of renovations were made by the row houses (84%) followed by the historic housing (81%). Of course, historic housing starts from the highest energy consumption levels, but it has more limitations.

On average, the 60 projects saved 76 percent, with 10 projects achieving 90 percent or more energy savings for the total demand for space heating, water heating and electricity for technical systems.

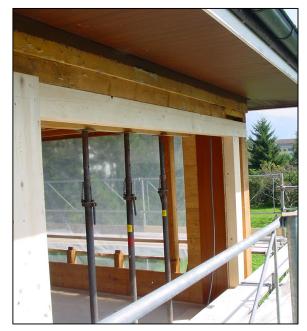
Fig. 2.6: Enlarging/adding window area, 411APT Stanssted CH (*photo: Beda Bossard Büro für Baubiologie, Bauökologie & Energie*)

411 APT Stansstad CH: Here, the windows were removed and all openings increased on the SE and SW facades to increase the daylighting of the living spaces (fig. 2.6). Also, newly constructed balconies have a glass floor to admit more daylight into the windows behind the balconies.

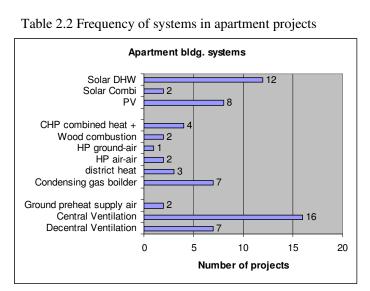
The most frequent means of producing heat was a condensing gas boiler (mostly the existing system). Four projects have combined heat and power systems. This is possible because of the larger absolute demand of apartment buildings compared to the other housing types.

Central ventilation systems outnumber decentral systems 16 to 7.

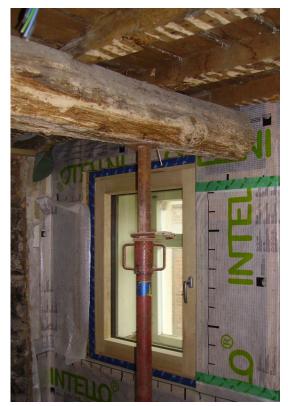
Fig. 3.1: Interior insulation of the street façade 222 ROW house in Eupen BE (*Brochure: Wouter Hilderson & Johan Cre*)

A clever system was used to insulate the street facade (fig. 3.1). The floors were cut away from the facade and a new wooden I-frame interior wall constructed and the void filled with cellulose. This allowed a continuous insulation of the entire street façade. A variable permeability vapor barrier prevents winter room humidity from passing into the wall in winter, but allows the insulation to dry out in summer. The vapor resistance depends on the relative humidity, ranging from 0.25m to 10.5m. New windows were added on the room side of the existing windows. By placing the new windows in the new interior wall it was possible to size them with a glass area almost as big as the whole existing window opening, maximizing daylighting and view. New solar collectors shade upper storey windows in summer

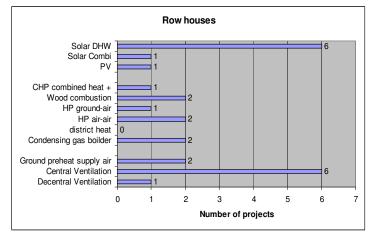
Table 3.2: Frequency of mech. systems in the eight row-house projects

Immediately evident is the popularity of solar thermal systems in 6 of the 8 row house projects, one being a combisystem for heating and dhw.

Central ventilation systems for each individual house are common, one project used room ventilators and one had no ventilation system.

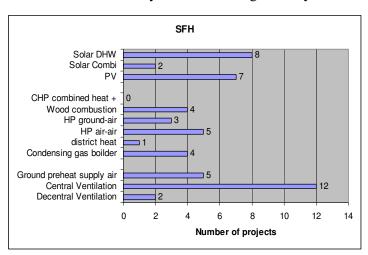
Table 4.2: Technical systems in the single family houses

Solar is popular among owners these single family houses owners, with 8 of the 15 projects having solar thermal systems and 7 having a PV system.

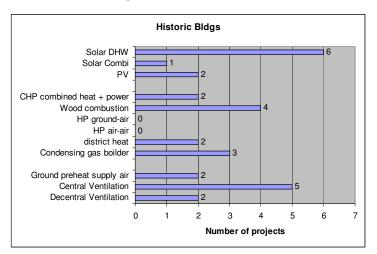
Table 5.2: Technical systems in the ten historic buildings:

Of the 10 historical buildings, six managed to get solar thermal collectors on roofs.

As passes to a historic building, wood combustion remained the most chosen heating source, besides also condensing gas furnaces.

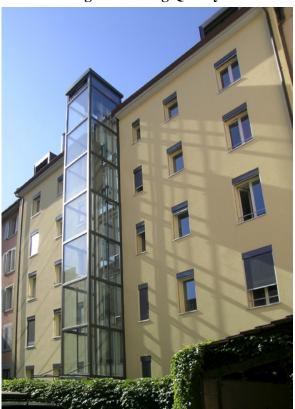
Fig. 5.5: Elevator addition in rear courtyard of 442 HIST Zurich. (*Photo: D. Enz*)
