Semi-detached house in De Pinte, Belgium

Retrofit of a semi-detached house from the 50's approaching Passive House Standard.

IEA – SHC Task 37

Advanced Housing Renovation with Solar & Conservation

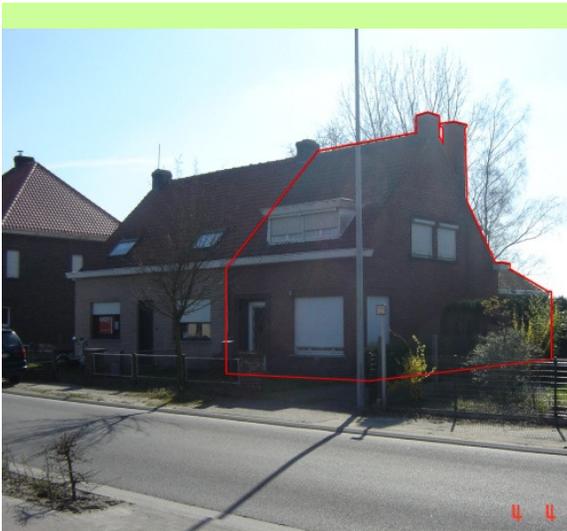
The original front view of the dwelling

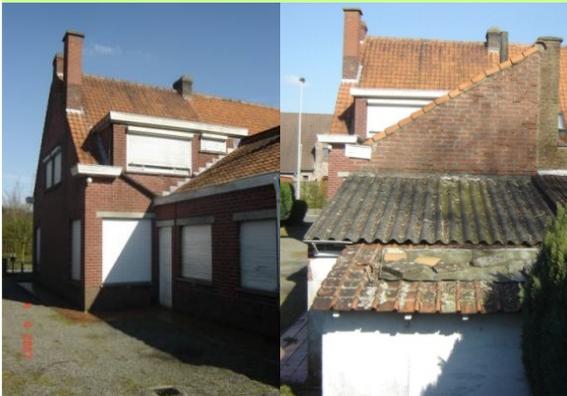
The original back view of the dwelling

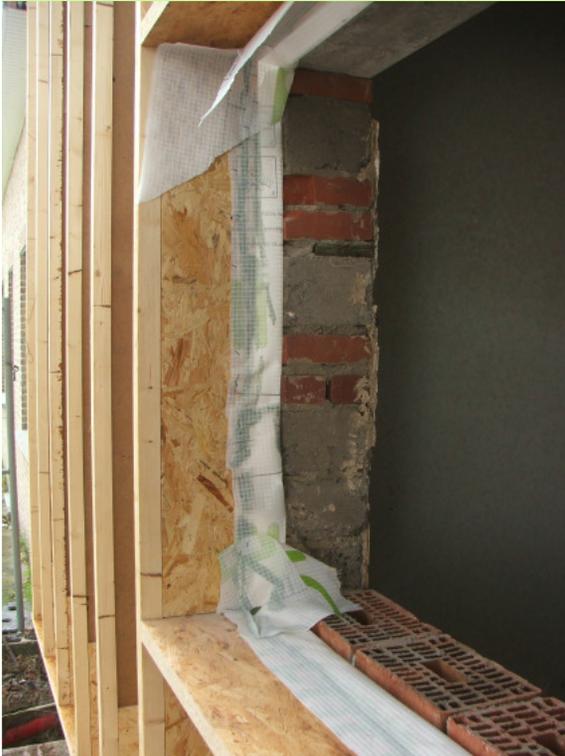
Timber frame construction fixed to the existing wall. The originally wall was erected with concrete blocks, but during the retrofit and the adaptation of the windows some clay tile blocks were build in.

The old house was built with a traditional, uninsulated cavity wall construction. The exterior brick facing was replaced by a timber frame construction fixed to the inner walls. The cavity was insulated. During construction, it became clear that the inner wall was far from straight. In places a difference of 7 cm had to be gapped.

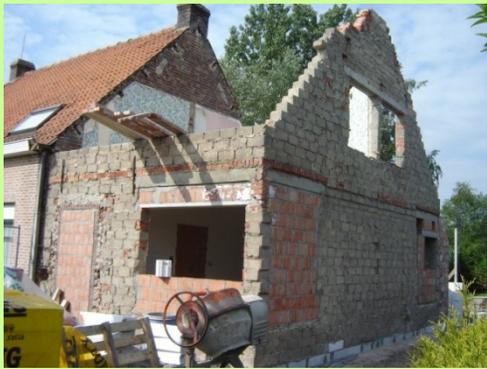
The house after dismantling the walls

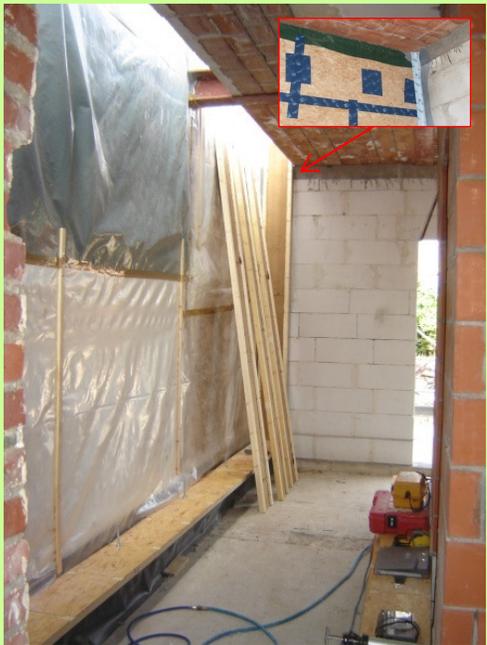
The construction of the common wall

The joint between the facade and common wall was another problem. Here, no real solution was found, but adding an additional insulation layer on the inner wall greatly reduced the thermal bridging effect.

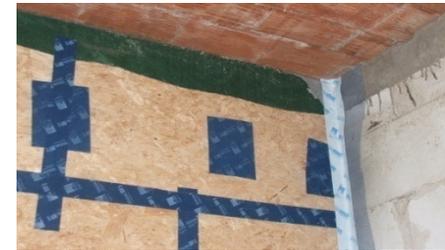
Taping off the OSB boards, and connection between OSB and plaster on the brick walls (the white band in the upper photo)

Connections between the masonry and timber constructions were critical. Special bands that can be plastered were used to make this connection.

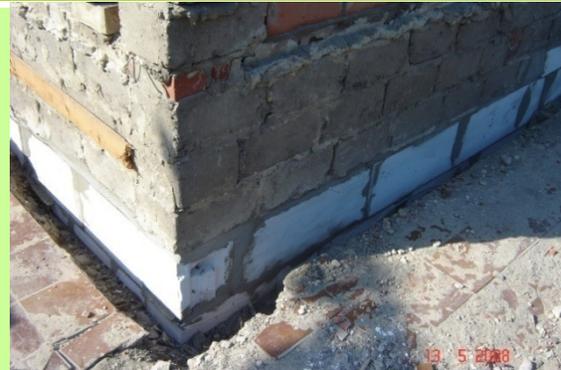
Thermal break at the base of the walls

A common, major thermal bridge in renovations is the base of the wall. Because a moisture barrier had to be installed anyway, it was decided to replace the first layer of bricks by cellular concrete.

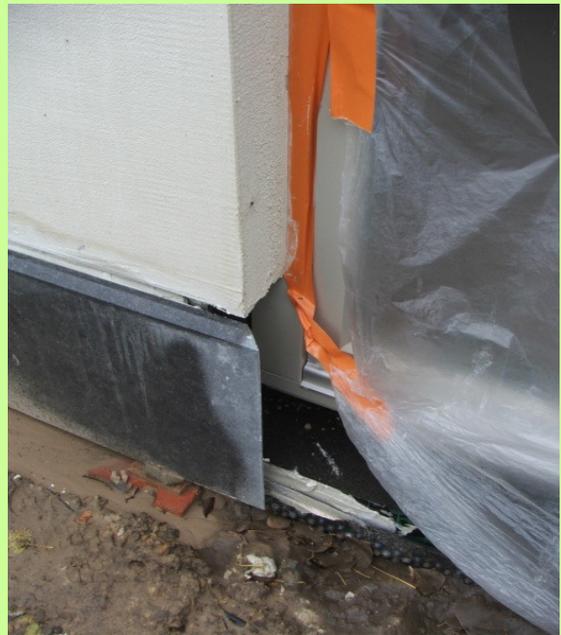
Connection threshold with frontdoor.

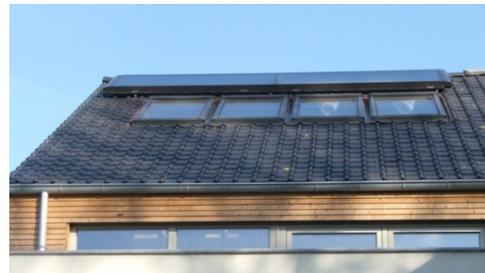
The roof windows and the solar thermal collector.

Finally, installation of the skylights was studied. Because of their positioning outside of the roof construction, the thermal bridging effect was even greater. To reduce this, a second window was placed underneath the skylight.

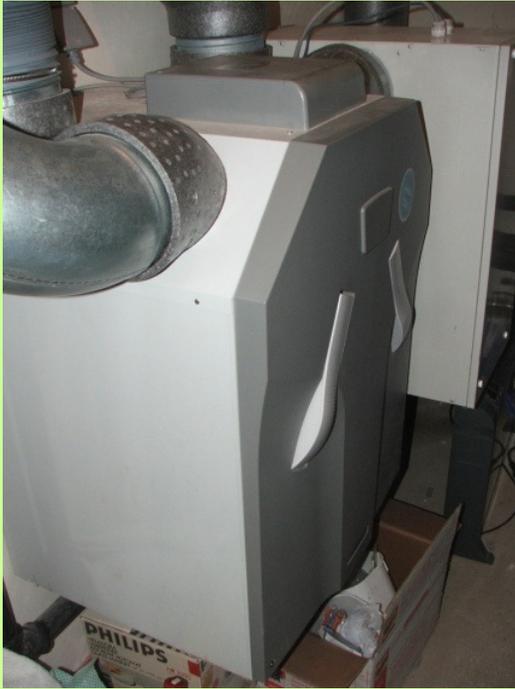
Mechanical ventilation unit.

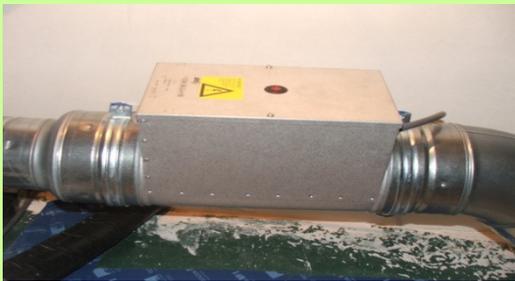
An electrical resistance for post heating the living areas.
